Please find enclosed a copy of the Slope Stability Study performed on the area above our Cottonwood Pit. In addition, I have included a map of our permit area.

SUMMARY

An evaluation of the landslide adjacent to the Canyon Cove #2 Subdivision, Salt Lake County, Utah is the subject of this report. The study was authorized and undertaken at the request of Mr. Jay L. Murphy, Wasatch Boulevard and Canyon Cove Company, Salt Lake City, Utah.

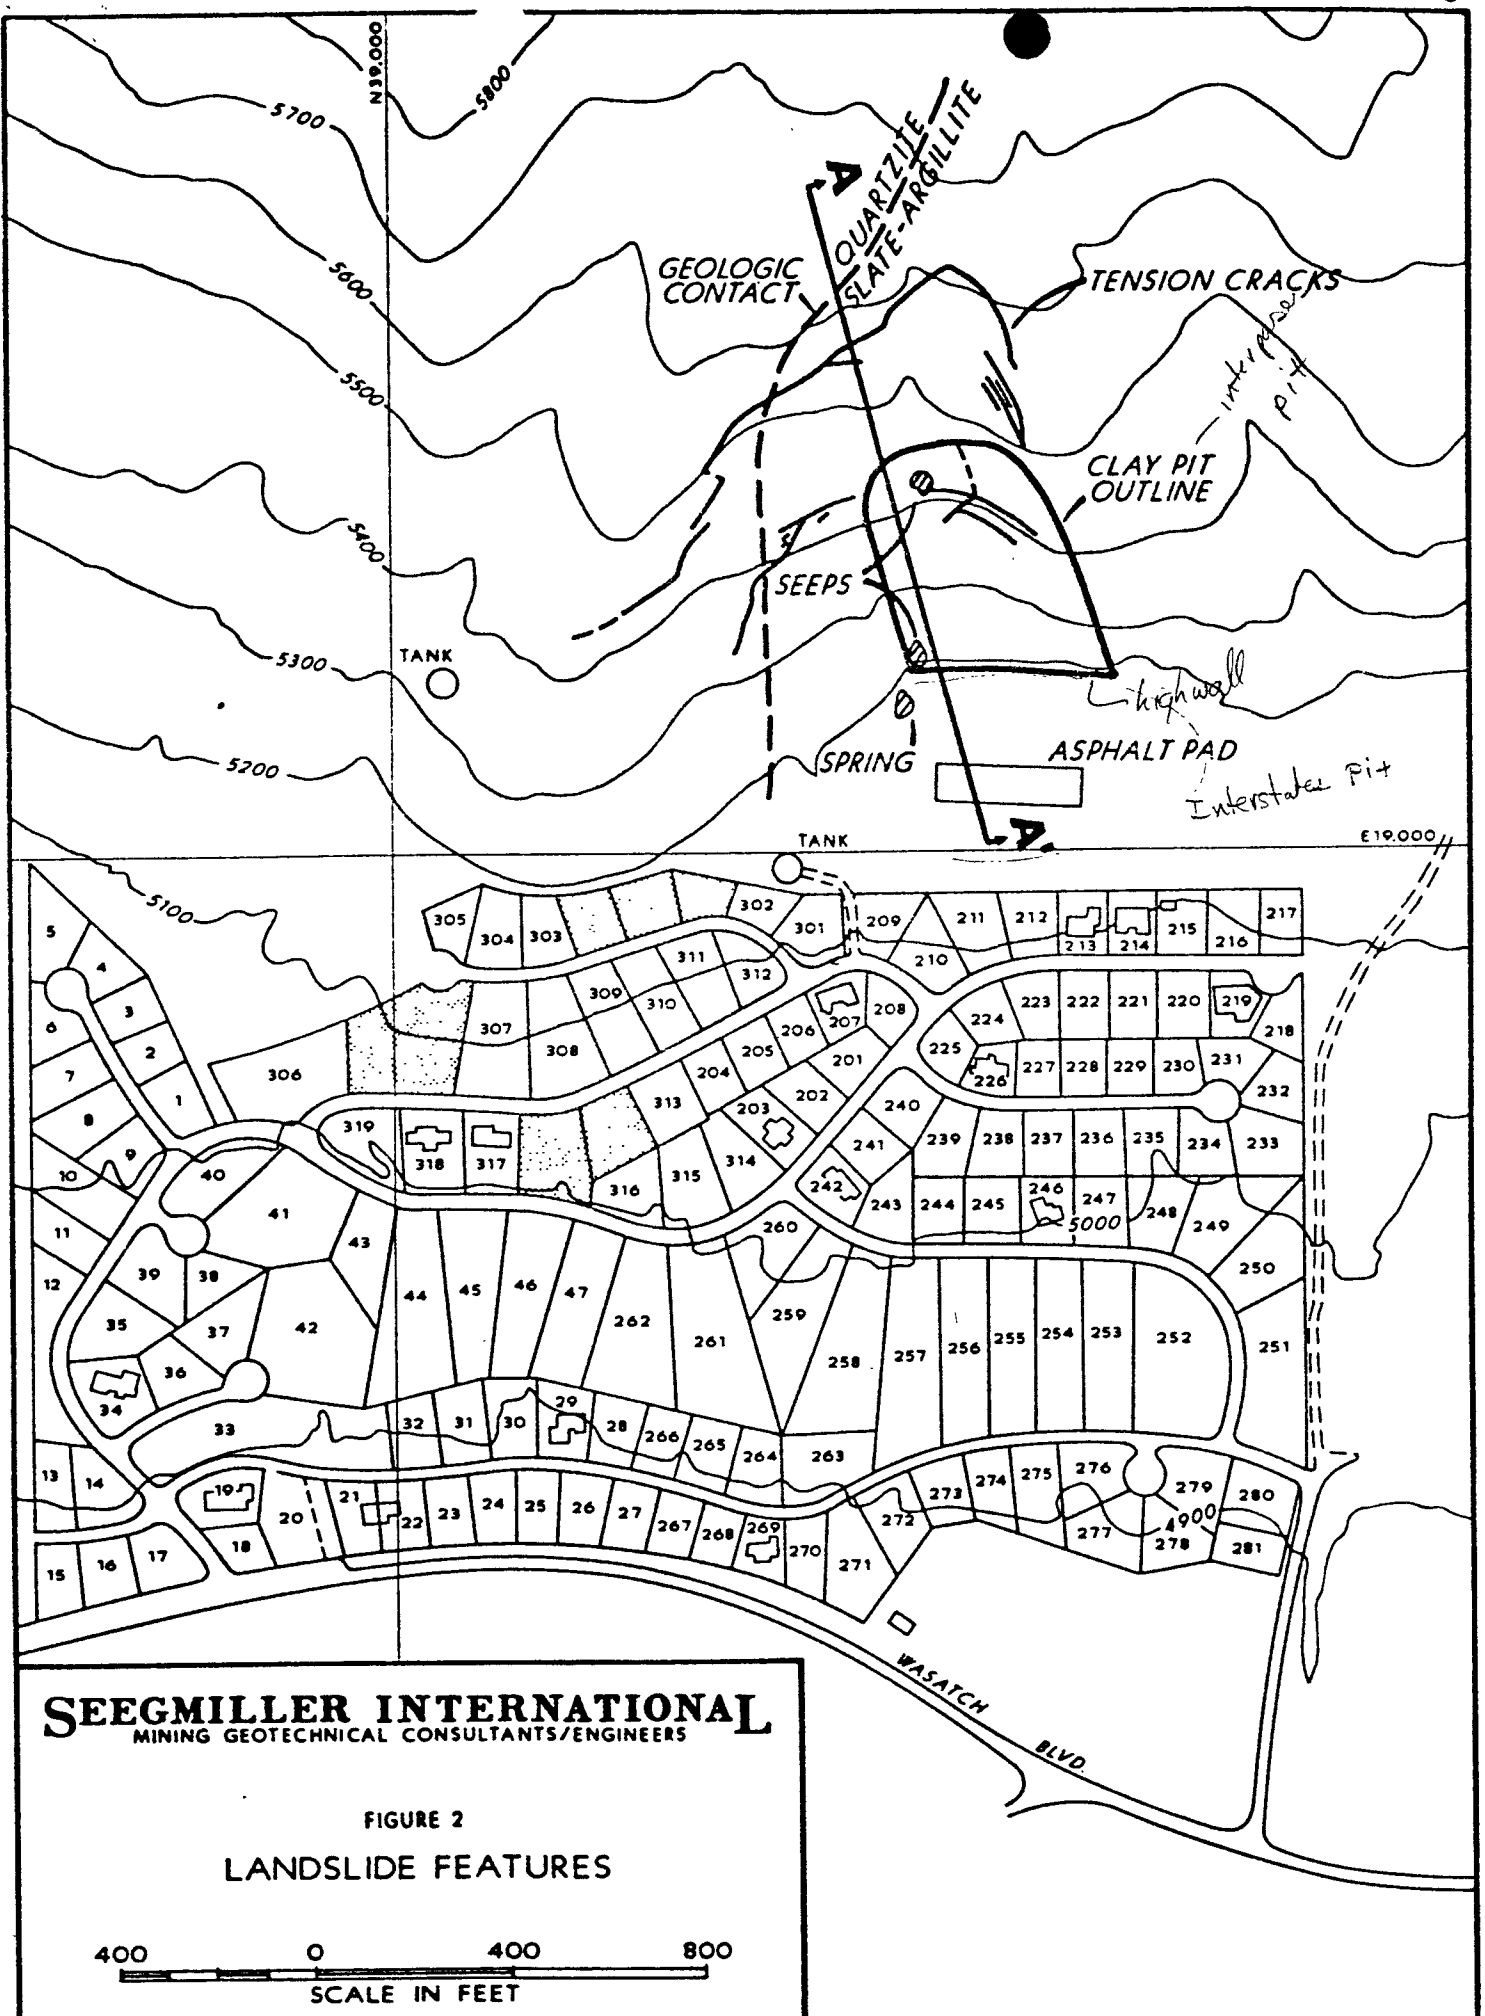
Direct Causes. The slope failure, or landslide, apparently⁵ first moved sometime in April 1983, but tended to stabilize with most movement ceasing by July 1983. Based on the various landslide data, visual summaries of which are presented in Figures 2 and 3, the landslide was a result of a number of factors. Groundwater is believed to be the most important of these factors and it was probably the triggering mechanism. The fact that the major movement occurred in the early spring of 1983, when groundwater levels and surface runoff were believed higher than usual, and the fact that groundwater still exists in the instability area are strong evidence that it actually triggered the movement. The existence of the mining operation is also a major factor in the cause of the slope instability. The fact that the main tension crack is located directly in back of the Clay Pit area, and approximately parallels the general shape of the mining zone, is strong evidence to suggest that the earth is undergoing a stress readjustment. The readjustment is in response to the creation of the Clay Pit and the removal of toe support materials. Another factor is that the geologic strata are oriented such that sliding could occur, at least in part, along weak bedding planes in slate-argillite on the south side of the moving zone. Further, the general rock mass strength is such that a fairly weak hillside initially existed. The weak mass was forced into stress disequilibrium by mining and then the rising groundwater pressurization caused a loss of effective stress, thus triggering the initial March 1983 movement.

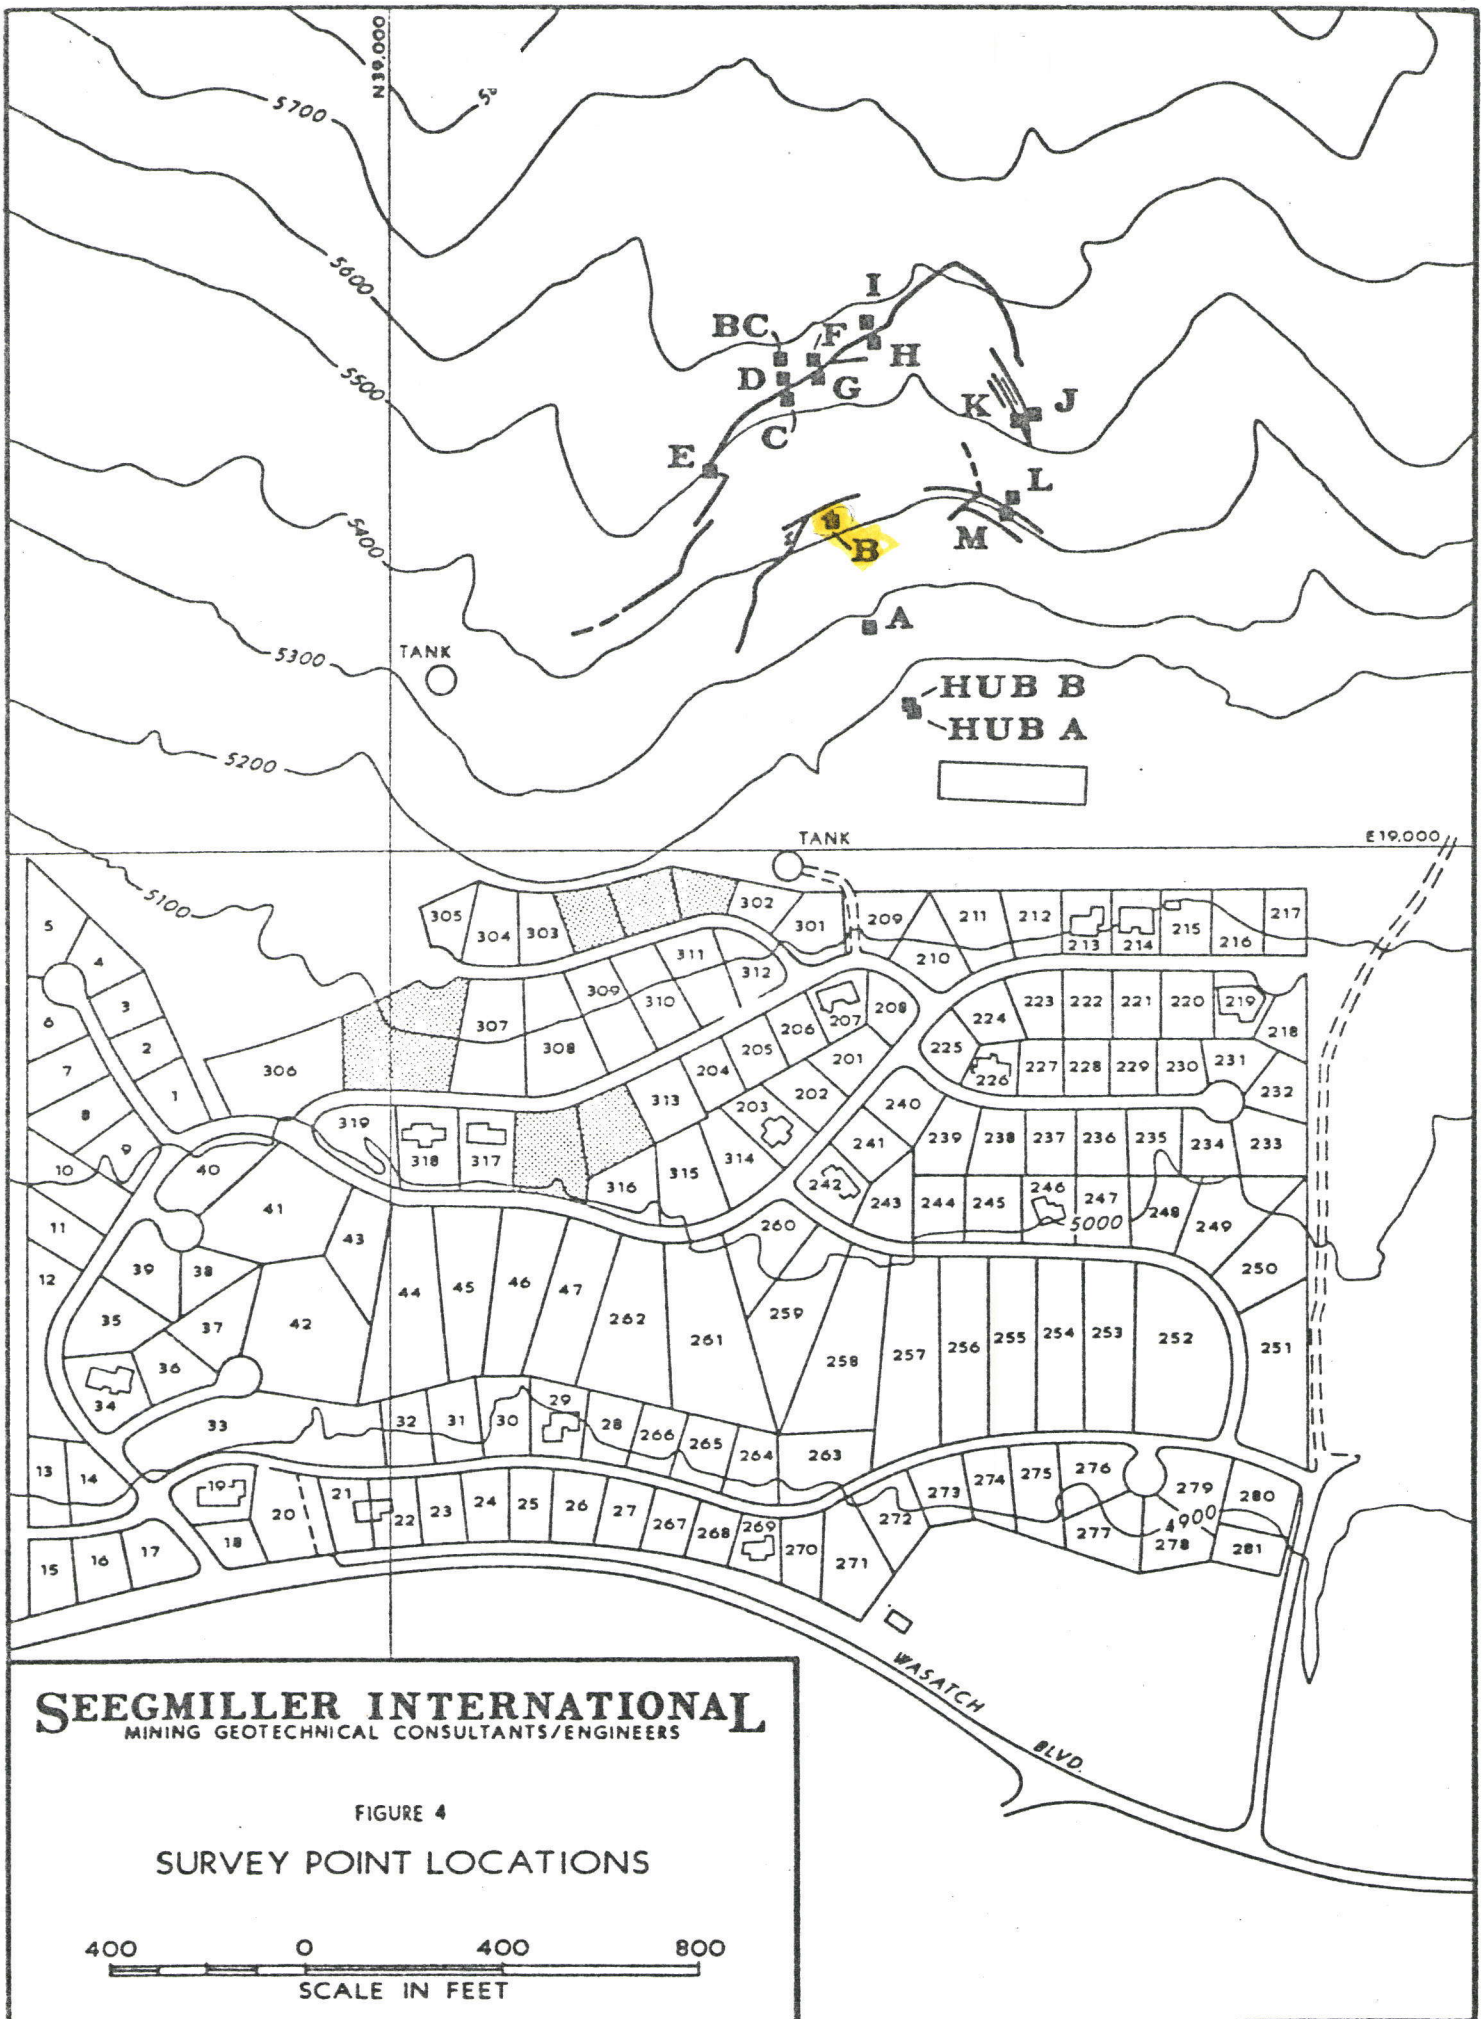
Cummulative Displacement. The Salt Lake County survey data⁸ were made available to SEEGMILLER in late August 1983. The data were analyzed and it was determined that the point showing the largest amount of movement was Point "B". In landslide displacement monitoring, the point showing the greatest movement is generally

the most likely point to first catastrophically displace. Therefore, Point "B" was selected for further displacement analysis. The survey data, when received, consisted of [1] horizontal east-west, [2] horizontal north-south and [3] vertical displacement values. These data were then combined to determine an overall displacement magnitude and displacement vector or direction. The overall displacement magnitude was approximately 1.61 feet for the 173 days during which Salt Lake County performed displacement monitoring. The direction of overall movement was S 74.6° W at an angle of 15.9° below horizontal. The displacement magnitudes serve as a measurement of the stability of a landslide and, as such, they are typically plotted for visual analysis. A common method for plotting the data is to plot cumulative displacement versus time. For Point "B" such a plot is shown in Figure 5. The total cumulative displacement magnitude is 1.77 feet and represents the summation of each individual movement occurring between surveying dates. Owing to the fact that such movements were not each in the overall displacement direction, their summation is 1.77 feet which is greater than the overall absolute displacement from the first survey date to the last survey date of 1.61 feet. In other words the shortest distance between two points is a straight line and that is less than a cumulative distance of many intermediate points, which do not lie on the straight line. The plot shown in Figure 5 indicates that movement of Point "B" has been dramatically lessening since late June 1983 and has shown very little movement from late August 1983 to late October 1983.

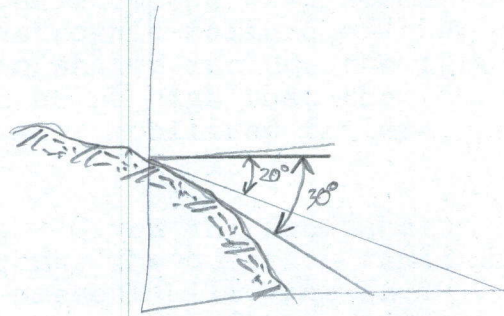
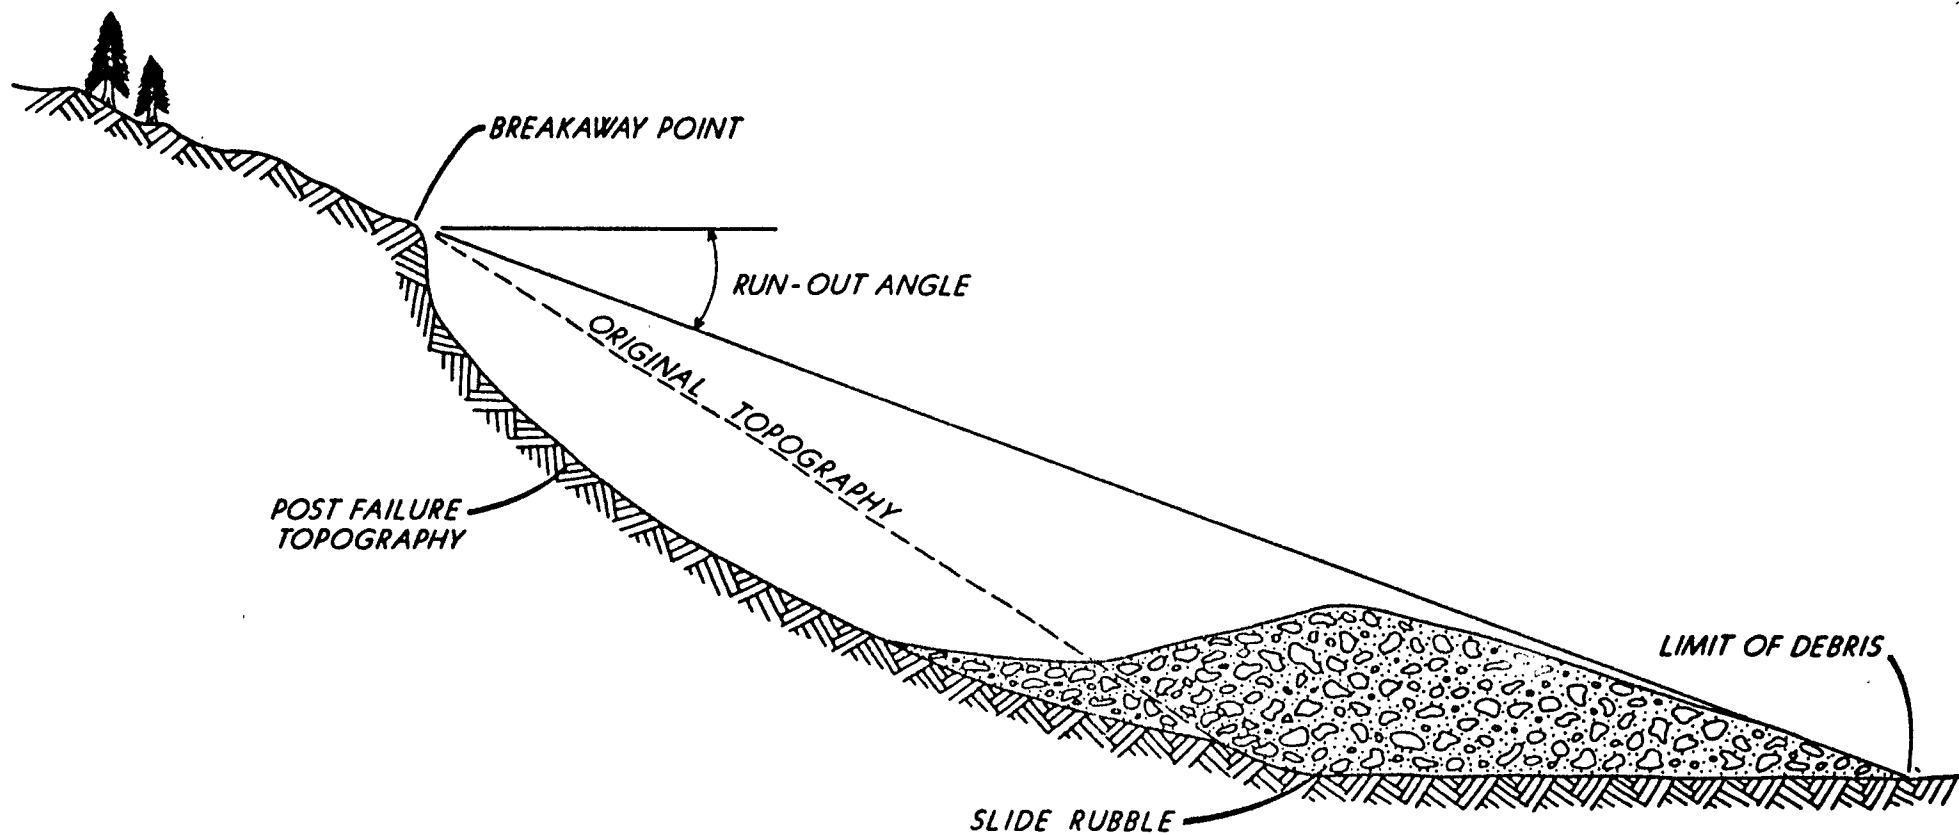
FIGURE 9
RUN-OUT ANGLE DEFINITION

Run-Out Analysis: Typical Landslide. A catastrophic landslide failure could occur as to how far in front of the toe of the sliding material could reach. To estimate the run-out mass, the concepts of Scheidegger¹¹ and others are used. These concepts pertain to the actual run-out of waste rock dumps that have been documented on natural slopes. The run-out angle is a function of the volume of the landslide in terms of volume. The run-out angle is defined as the angle below horizontal that the landslide will reach when measured at the breakaway point as shown in Figure 9. The volume of the Canyon Cove landslide was computed to be approximately 1.4 million cubic meters and using the Scheidegger criteria, a mean run-out angle of approximately 25° was determined. The standard deviation of the run-out angle was determined to be approximately ±5°. Assuming that the run-out angle values are part of a normal statistical distribution, the probability of not exceeding any particular run-out limit may be determined. For a 90% probability the run-out angle is determined to be greater than approximately 19°. For a 95% probability the run-out angle will be greater than 17°. In other words, three run-out magnitudes have been established. First, the most probable run-out limit is 25°. Secondly, there is a 90% probability that, if a landslide occurs, the run-out angle will be greater than 19°. Thirdly, given the fact that a landslide does occur, there is a 95% probability that the run-out limit will occur within a zone described by a 17° run-out angle. These magnitudes may be used to estimate the limits that the Canyon Cove landslide will reach should it fail. It should be noted that the concepts used to produce these run-out limits assume a landslide that is not water mobilized. It is tacitly assumed that the landslide will be induced by groundwater pressurization, but that the groundwater levels will not be so high that complete slope saturation and mudflow conditions prevail. The estimated run-out limits for the most likely

conditions and the 90% and 95% probability conditions are shown in Figure 10. If greater probabilities are examined, the limits increase in the general southwest direction. These limits may be taken as the run-out limits for a slide occurring under circumstances similar to those that existed during the spring of 1983. The impact of this event on the water storage tank east of lots 301 and 302 may not be too bad because the tank is toward the side of the main run-out zone. The probability of the run-out area extending to the edge of the tank is estimated to be approximately 20%. However, the forces involved in landslides are known to be large and the exact limits of the run-out zone are not always predictable. Therefore, a cautious approach is recommended.
